TASK FORCE REPORT

PORTLAND CEMENT CONCRETE PAVEMENT PERFORMANCE INTERSTATE 84

PENNSYLVANIA STATE LINE TO CONNECTICUT STATE LINE

MARCH 1978

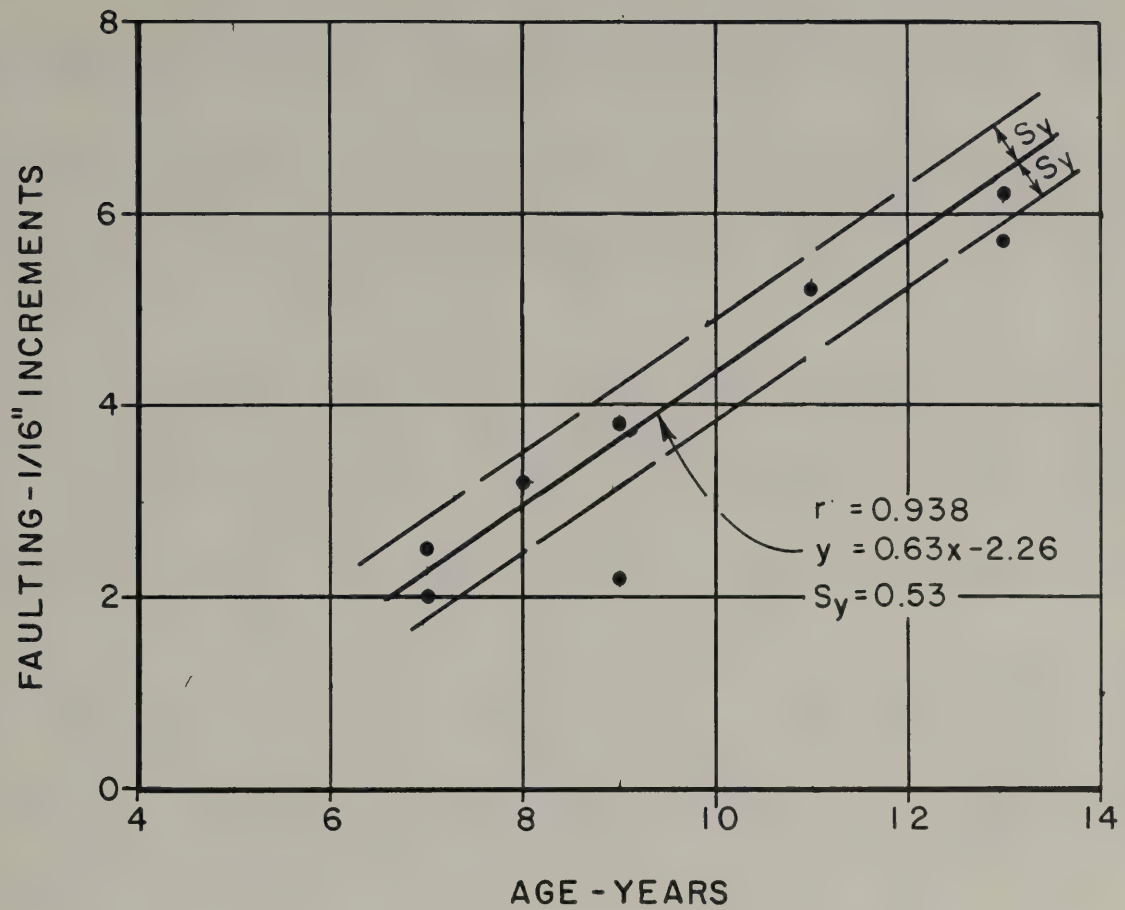
FIGURE I
REGRESSION ANALYSIS OF
FAULTING VS AGE

The results are shown in Figure 1. A significant correlation was obtained, indicating that the progression of faulting on this pavement can be predicted reasonably well and the newer contracts could reach the distress level of the older ones at similar ages. In other words, faulting will continue to increase unless corrective measures are taken.
